DEPARTMENT OF TRANSPORTATION

Contract #: 04-0120F4Cty: SF/ALA Rte: 80 PM: 13.2/13.9File #: 99.28**WELDING INSPECTION REPORT****Resident Engineer:**Siegenthaler, Peter**Address:** 333 Burma Road**City:** Oakland, CA 94607**Report No:** WIR-019303**Date Inspected:** 14-Jan-2011**Project Name:** SAS Superstructure**OSM Arrival Time:** 700**Prime Contractor:** American Bridge/Fluor Enterprises, a JV**OSM Departure Time:** 1900**Contractor:** Zhenhua Port Machinery Company, Ltd (ZPMC)**Location:** Shanghai, China**CWI Name:** Li Yang and Zhu Zhong Hai**CWI Present:** Yes No**Inspected CWI report:** Yes No N/A**Rod Oven in Use:** Yes No N/A**Electrode to specification:** Yes No N/A**Weld Procedures Followed:** Yes No N/A**Qualified Welders:** Yes No N/A**Verified Joint Fit-up:** Yes No N/A**Approved Drawings:** Yes No N/A**Approved WPS:** Yes No N/A**Delayed / Cancelled:** Yes No N/A**Bridge No:** 34-0006**Component:** OBG Trial Assembly**Summary of Items Observed:**

WELDING INSPECTION REPORT

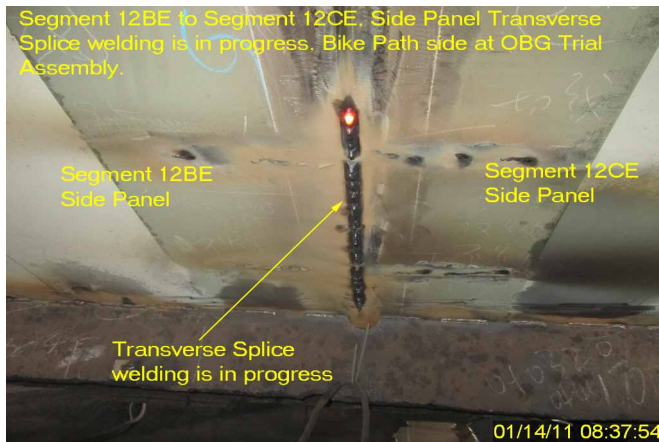
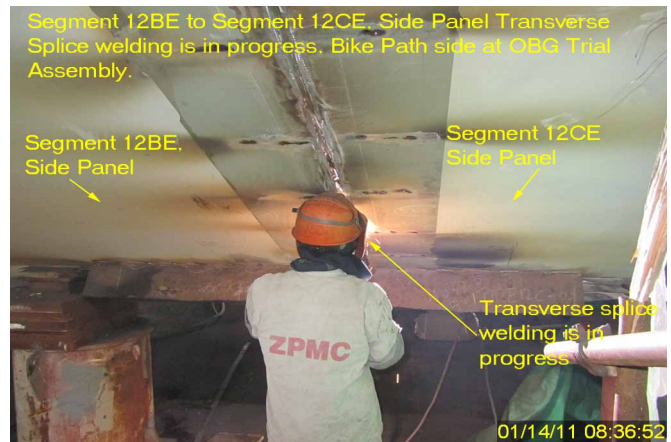
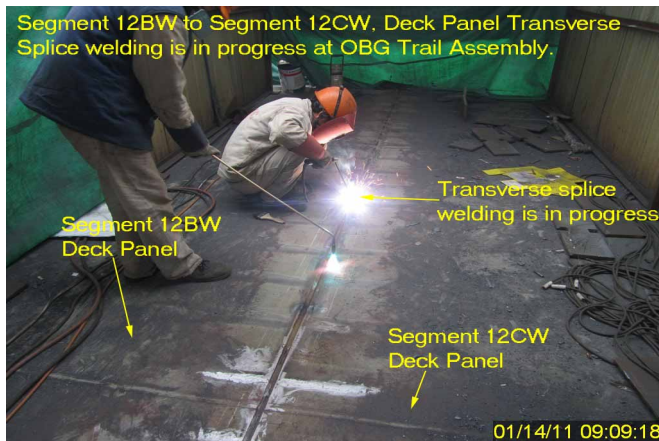
Please reference the pictures attached for more comprehensive details.
